Case 324 : Narrative

Case Vehicle (A): 2000 Dodge
Type: Stratus SE, 4-door sedan
Driver: 20-year-old female
CDC: 12-FDEW-5

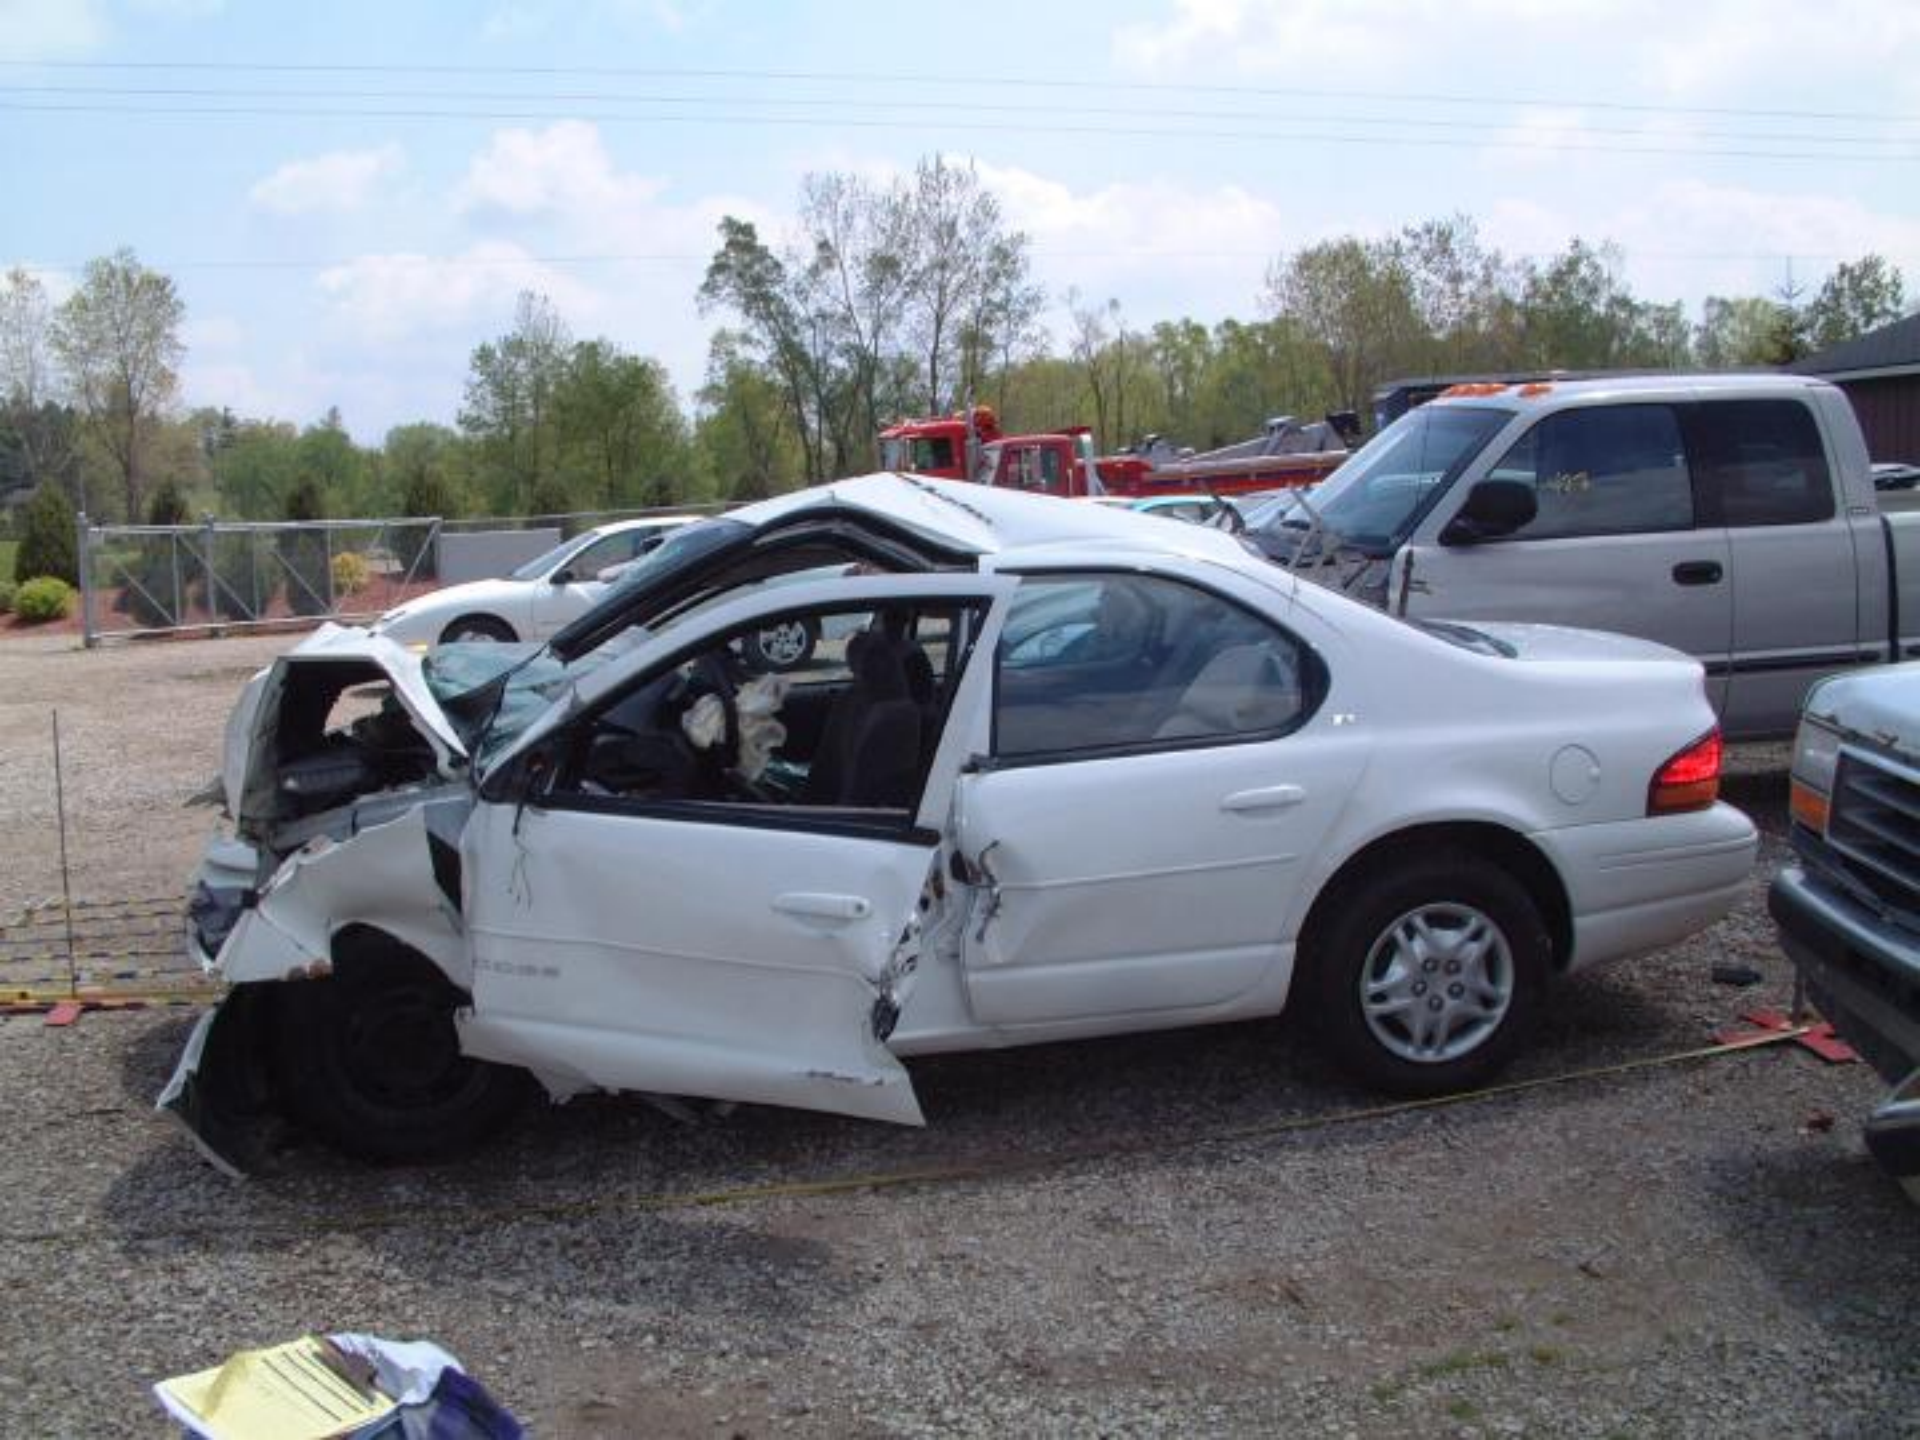
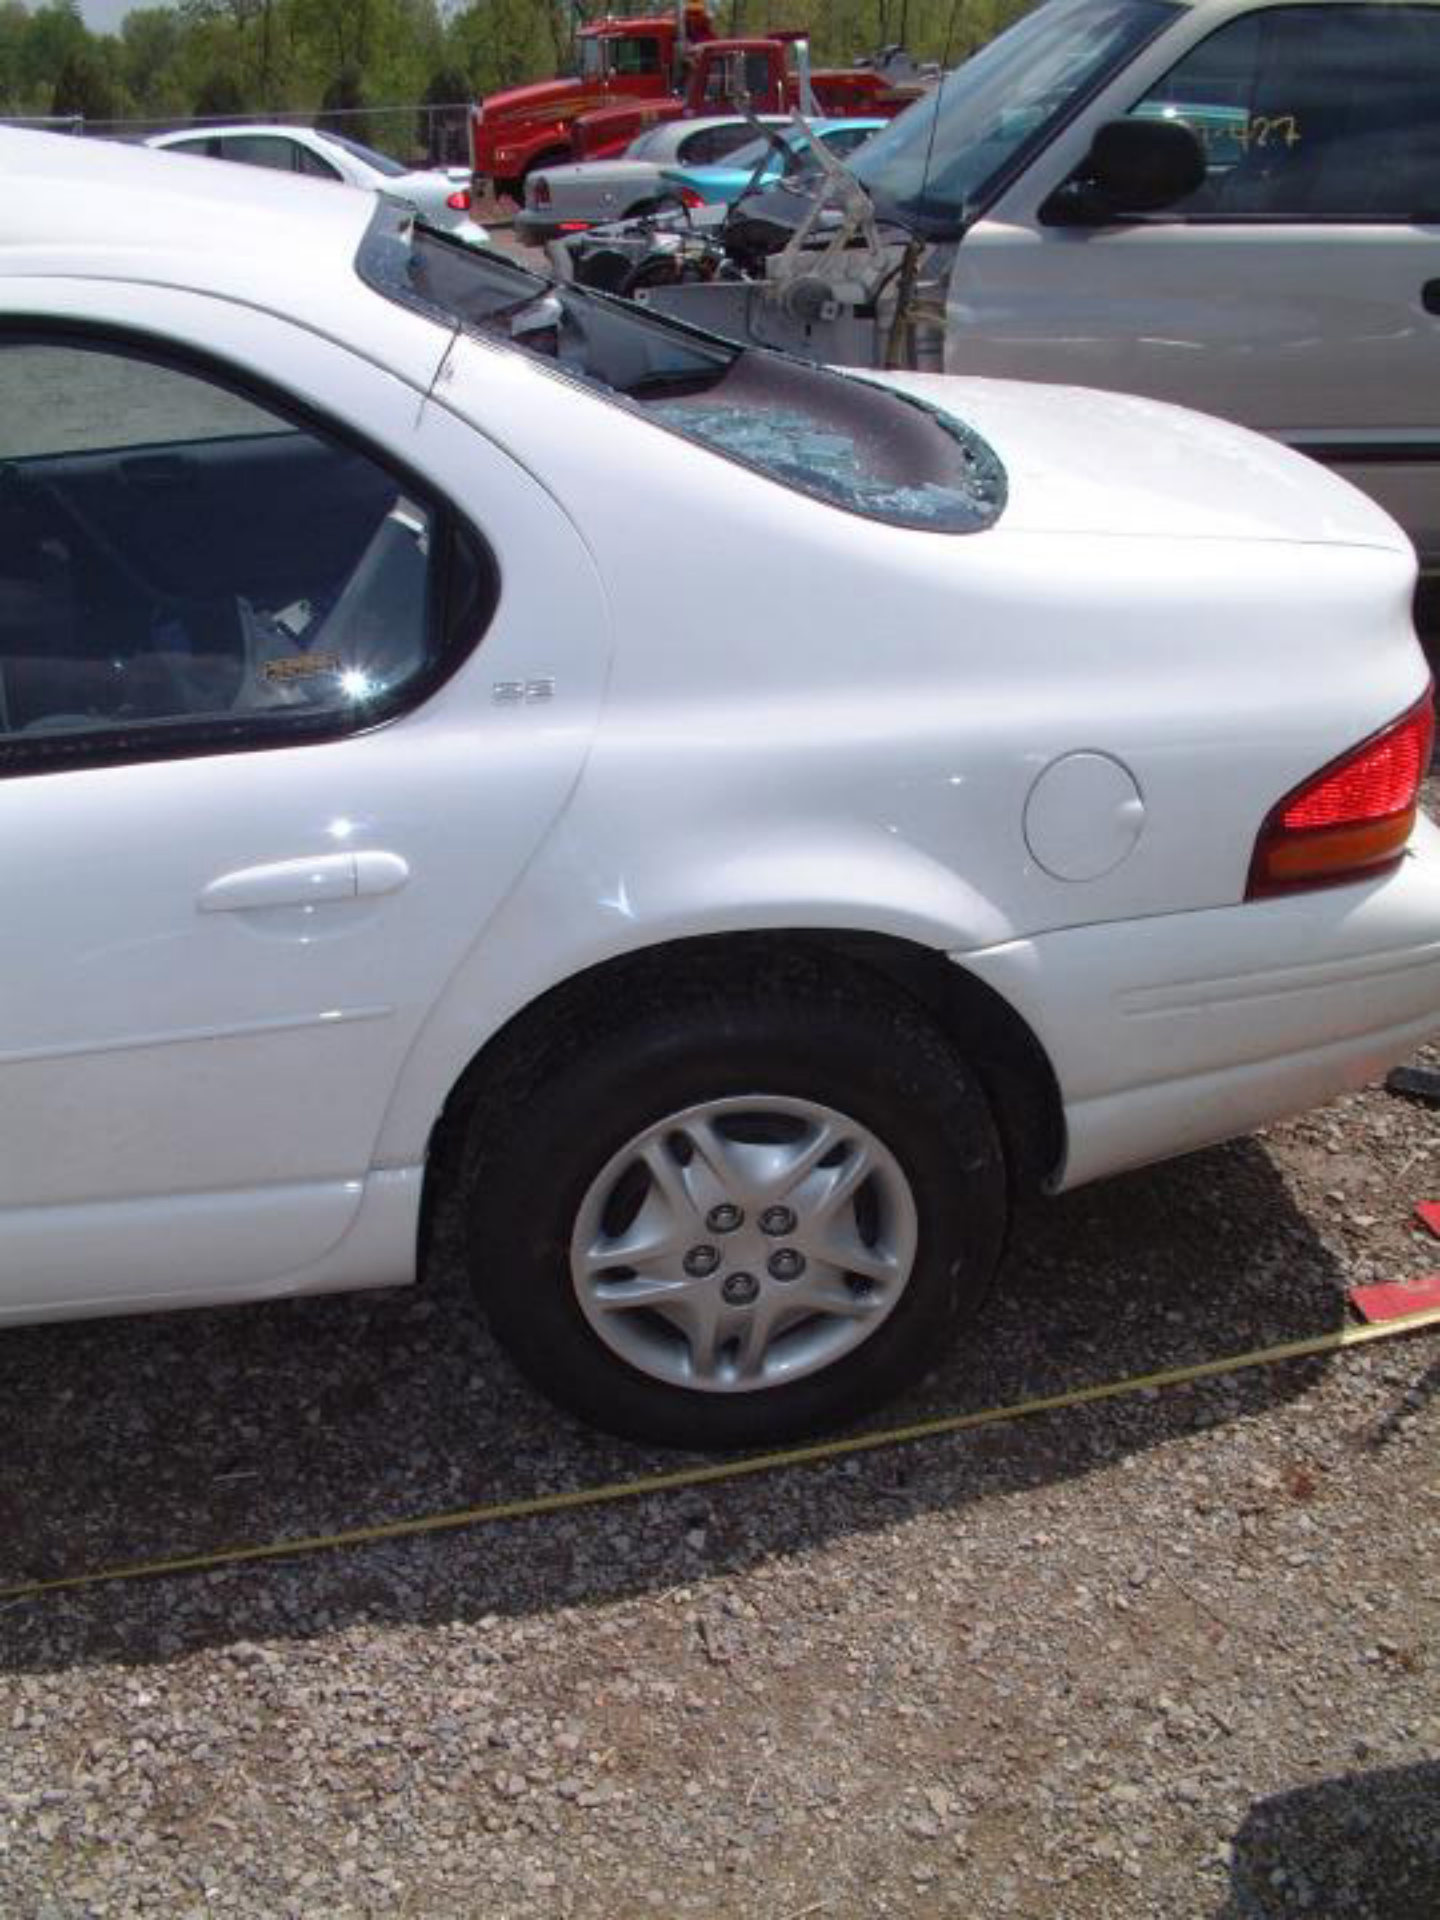
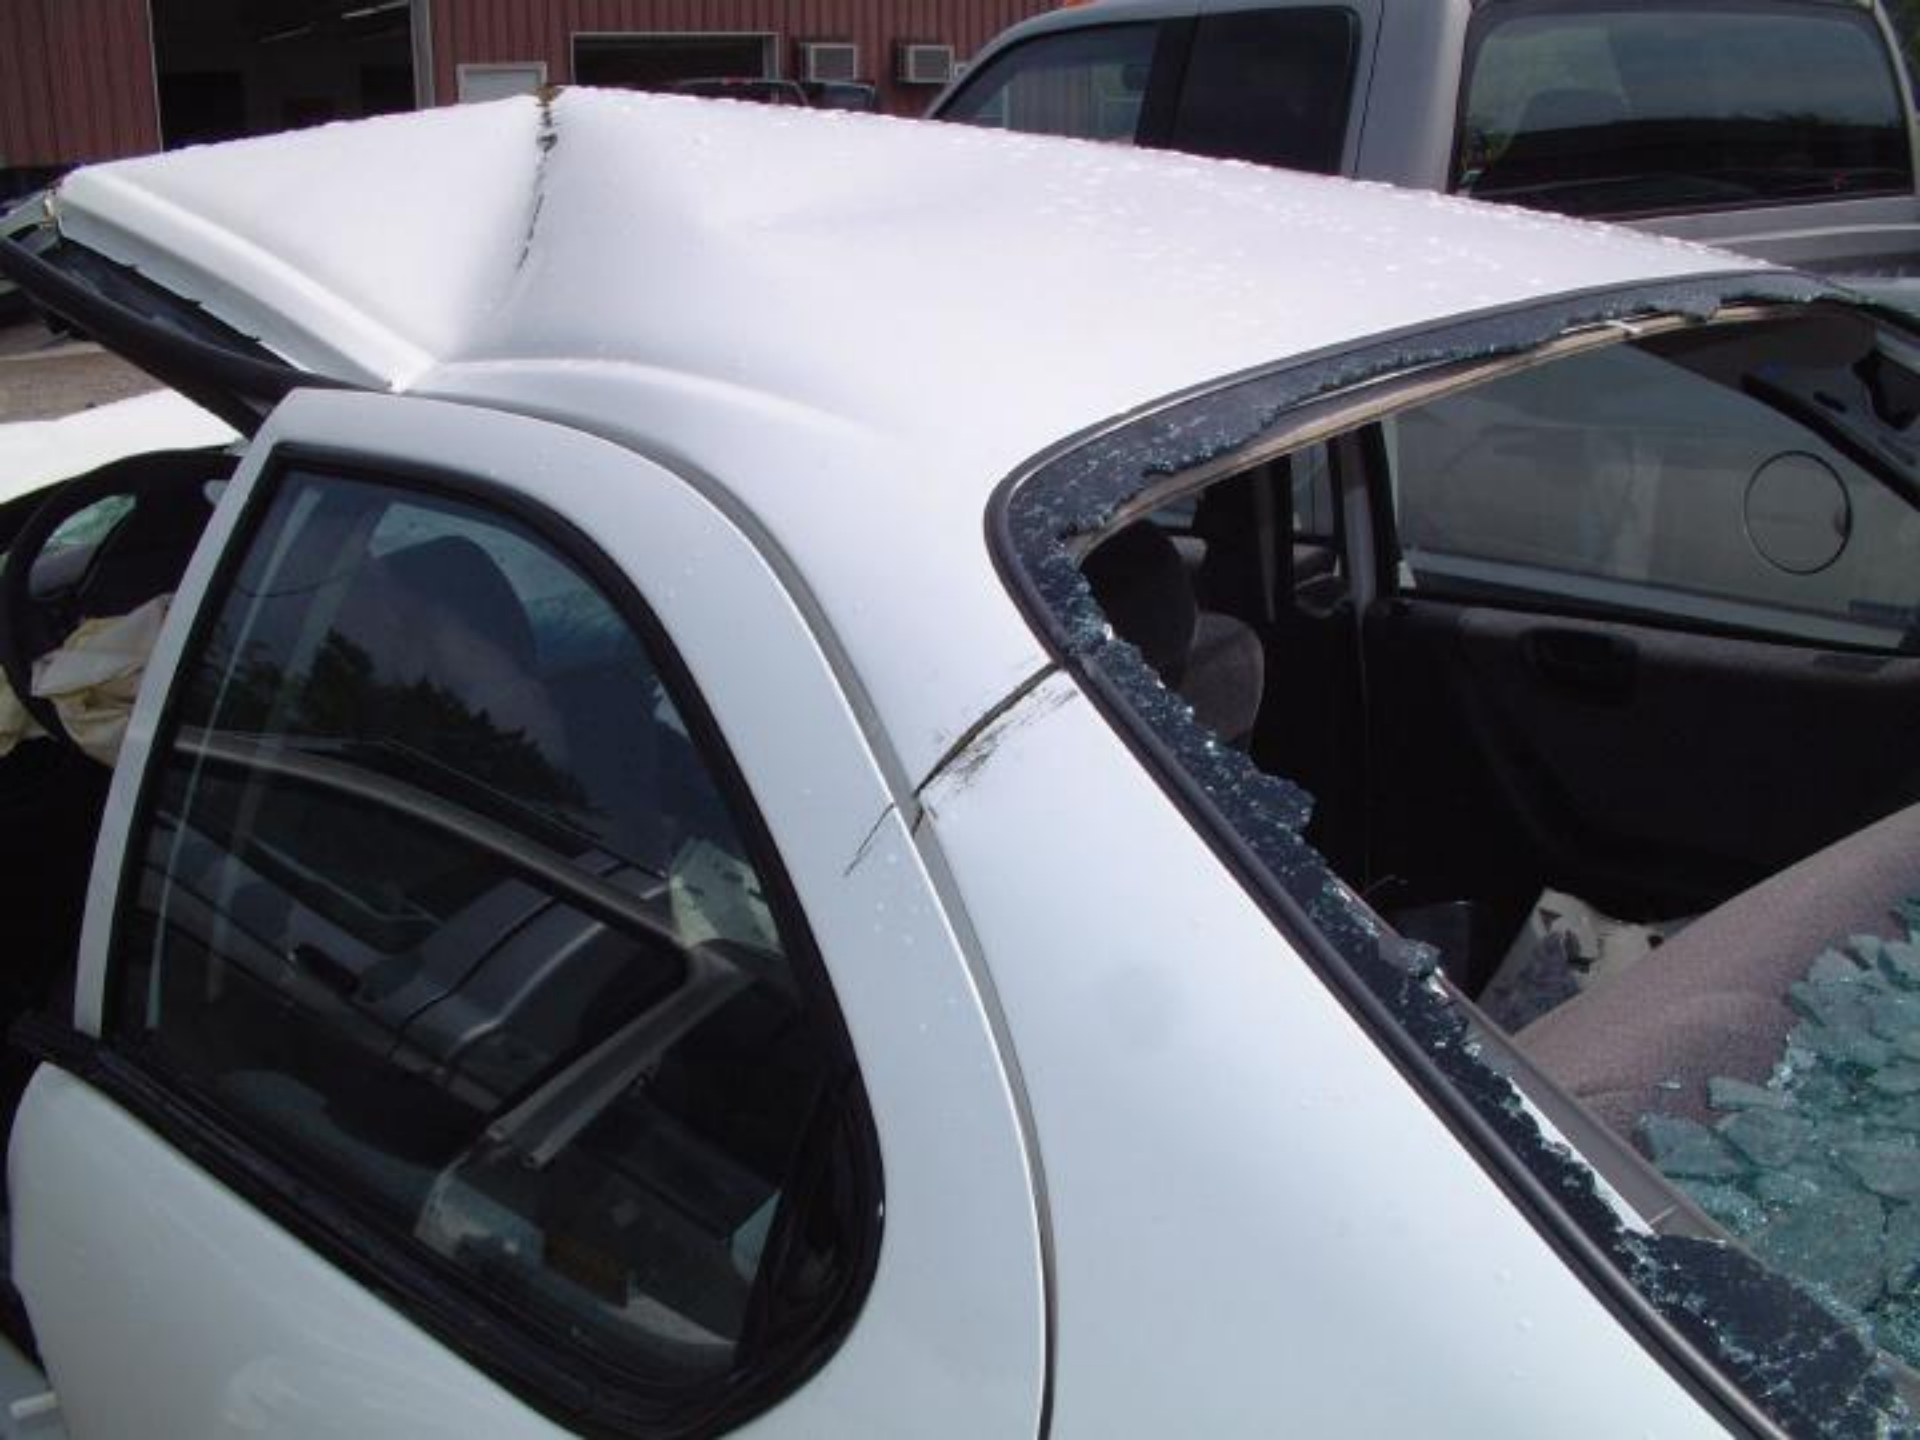
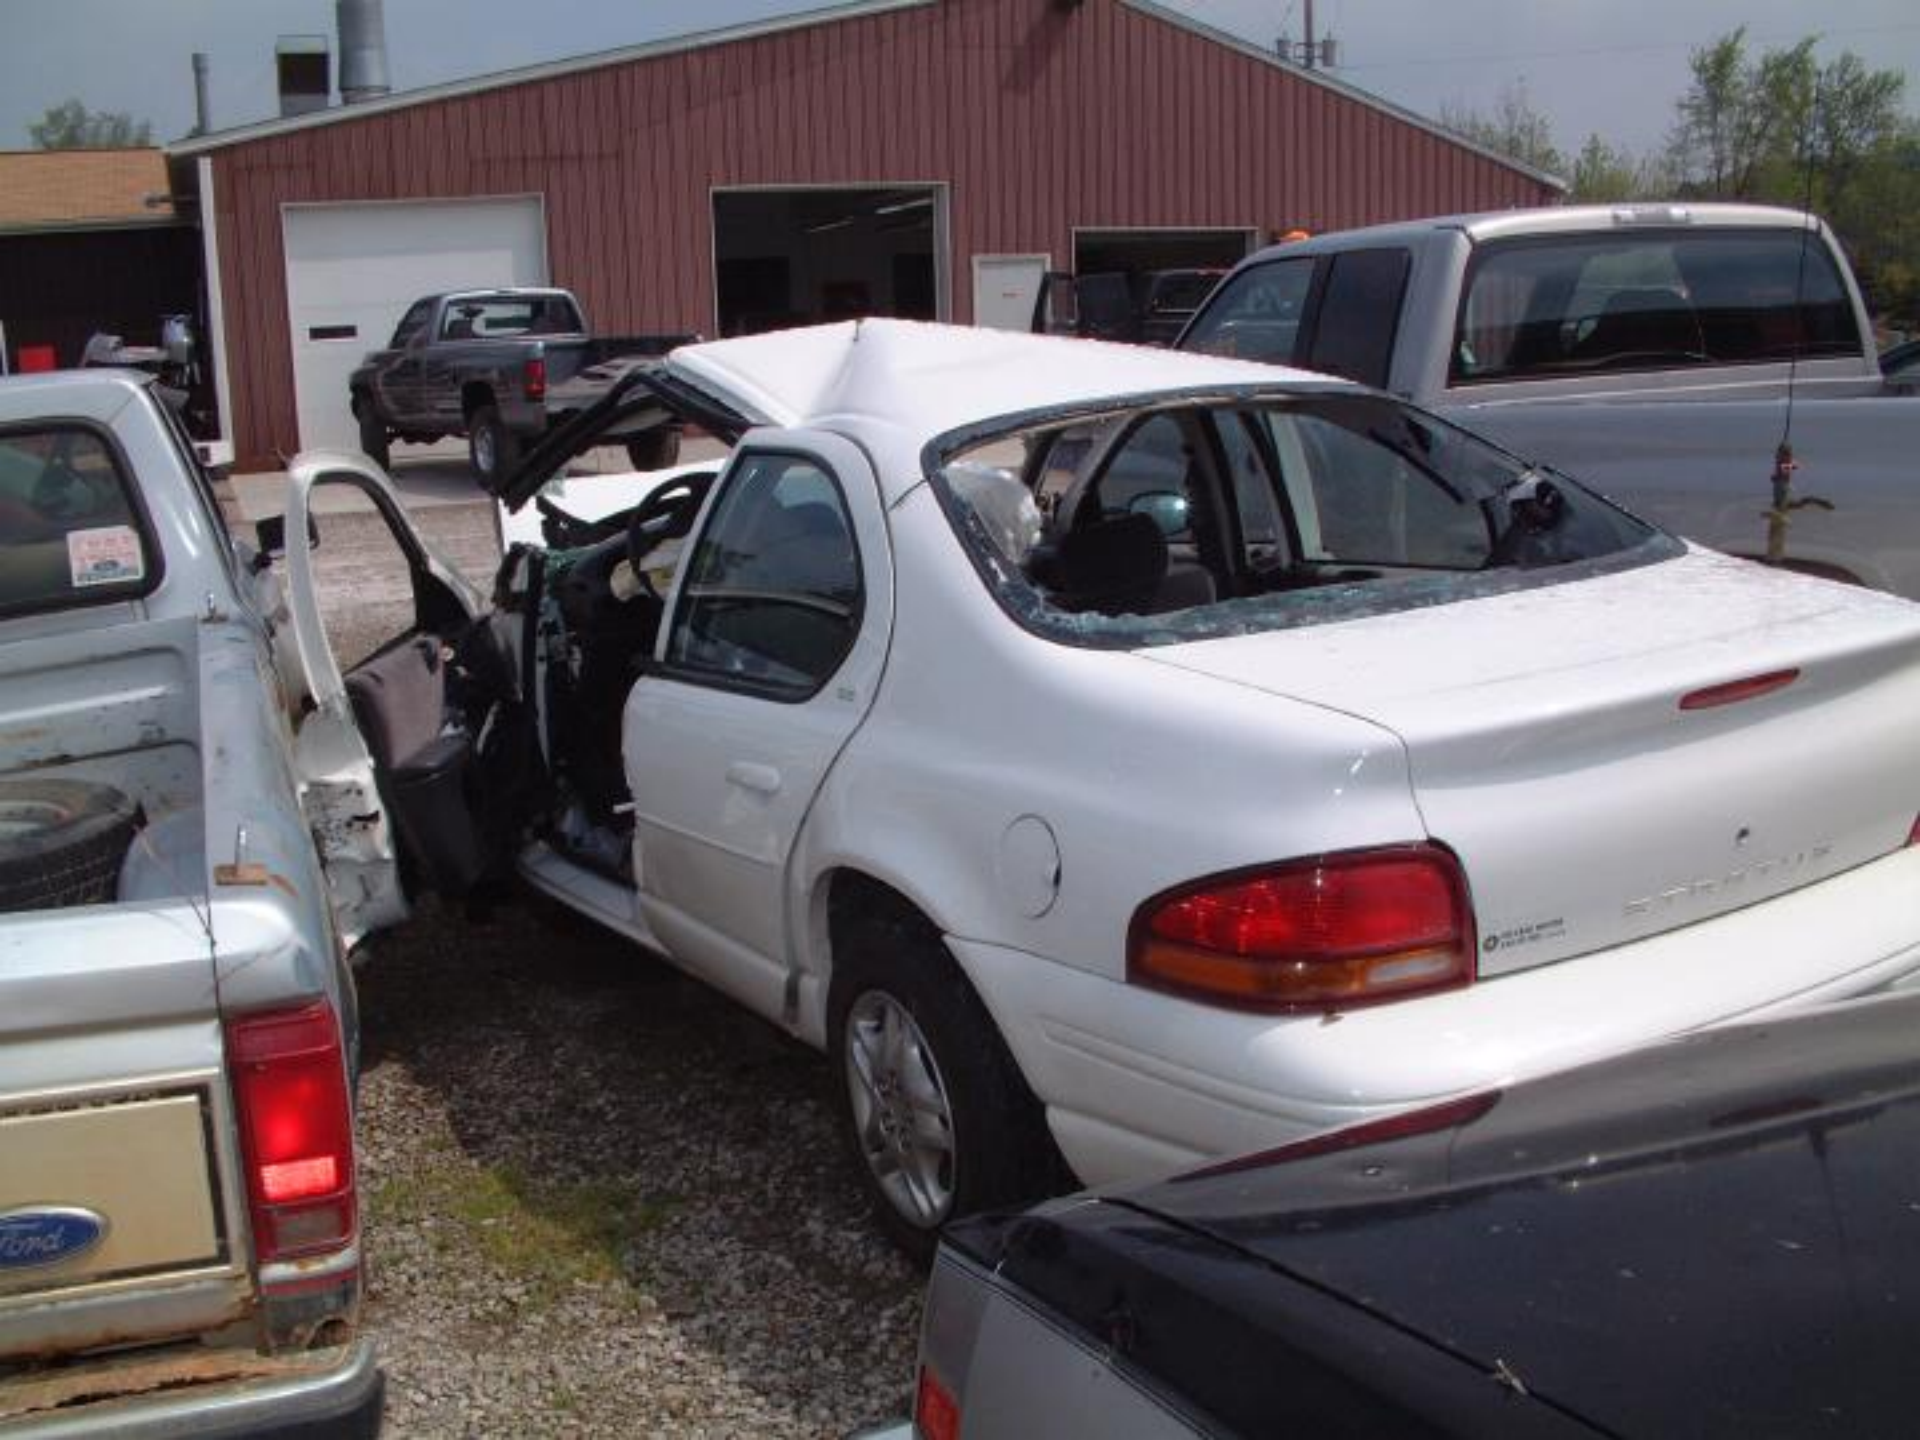
[42](#) This vehicle was equipped with steering-wheel and passenger frontal-impact airbags, which deployed during the frontal impact. [43](#) There were blood droplets on the rear, upper, and left portions of the airbag skin. [44](#) [45](#) [46](#) [47](#) There was also a black patch of melted airbag fabric and a large tear on the right-rear portion of the airbag. This tear is thought to have been caused by interaction of the airbag with the wiper control level on the right side of the steering column during rapid clockwise rotation of the steering wheel and airbag module at the time of airbag deployment, which was partially forward through the steering-wheel rim due to the relatively close proximity of the driver. [48](#) [49](#) During inspection, the steering wheel was rotated 180 degrees from the normal position, and the upper half of the steering-wheel rim, which was at the bottom, was deflected forward approximately 11 cm. The upper steering wheel spokes were also slightly deformed, and the top half of the airbag flap was displaced forward and stuck behind the upper portion of the steering-wheel rim. [50](#) In addition, the steering column was rotated up and to the left.

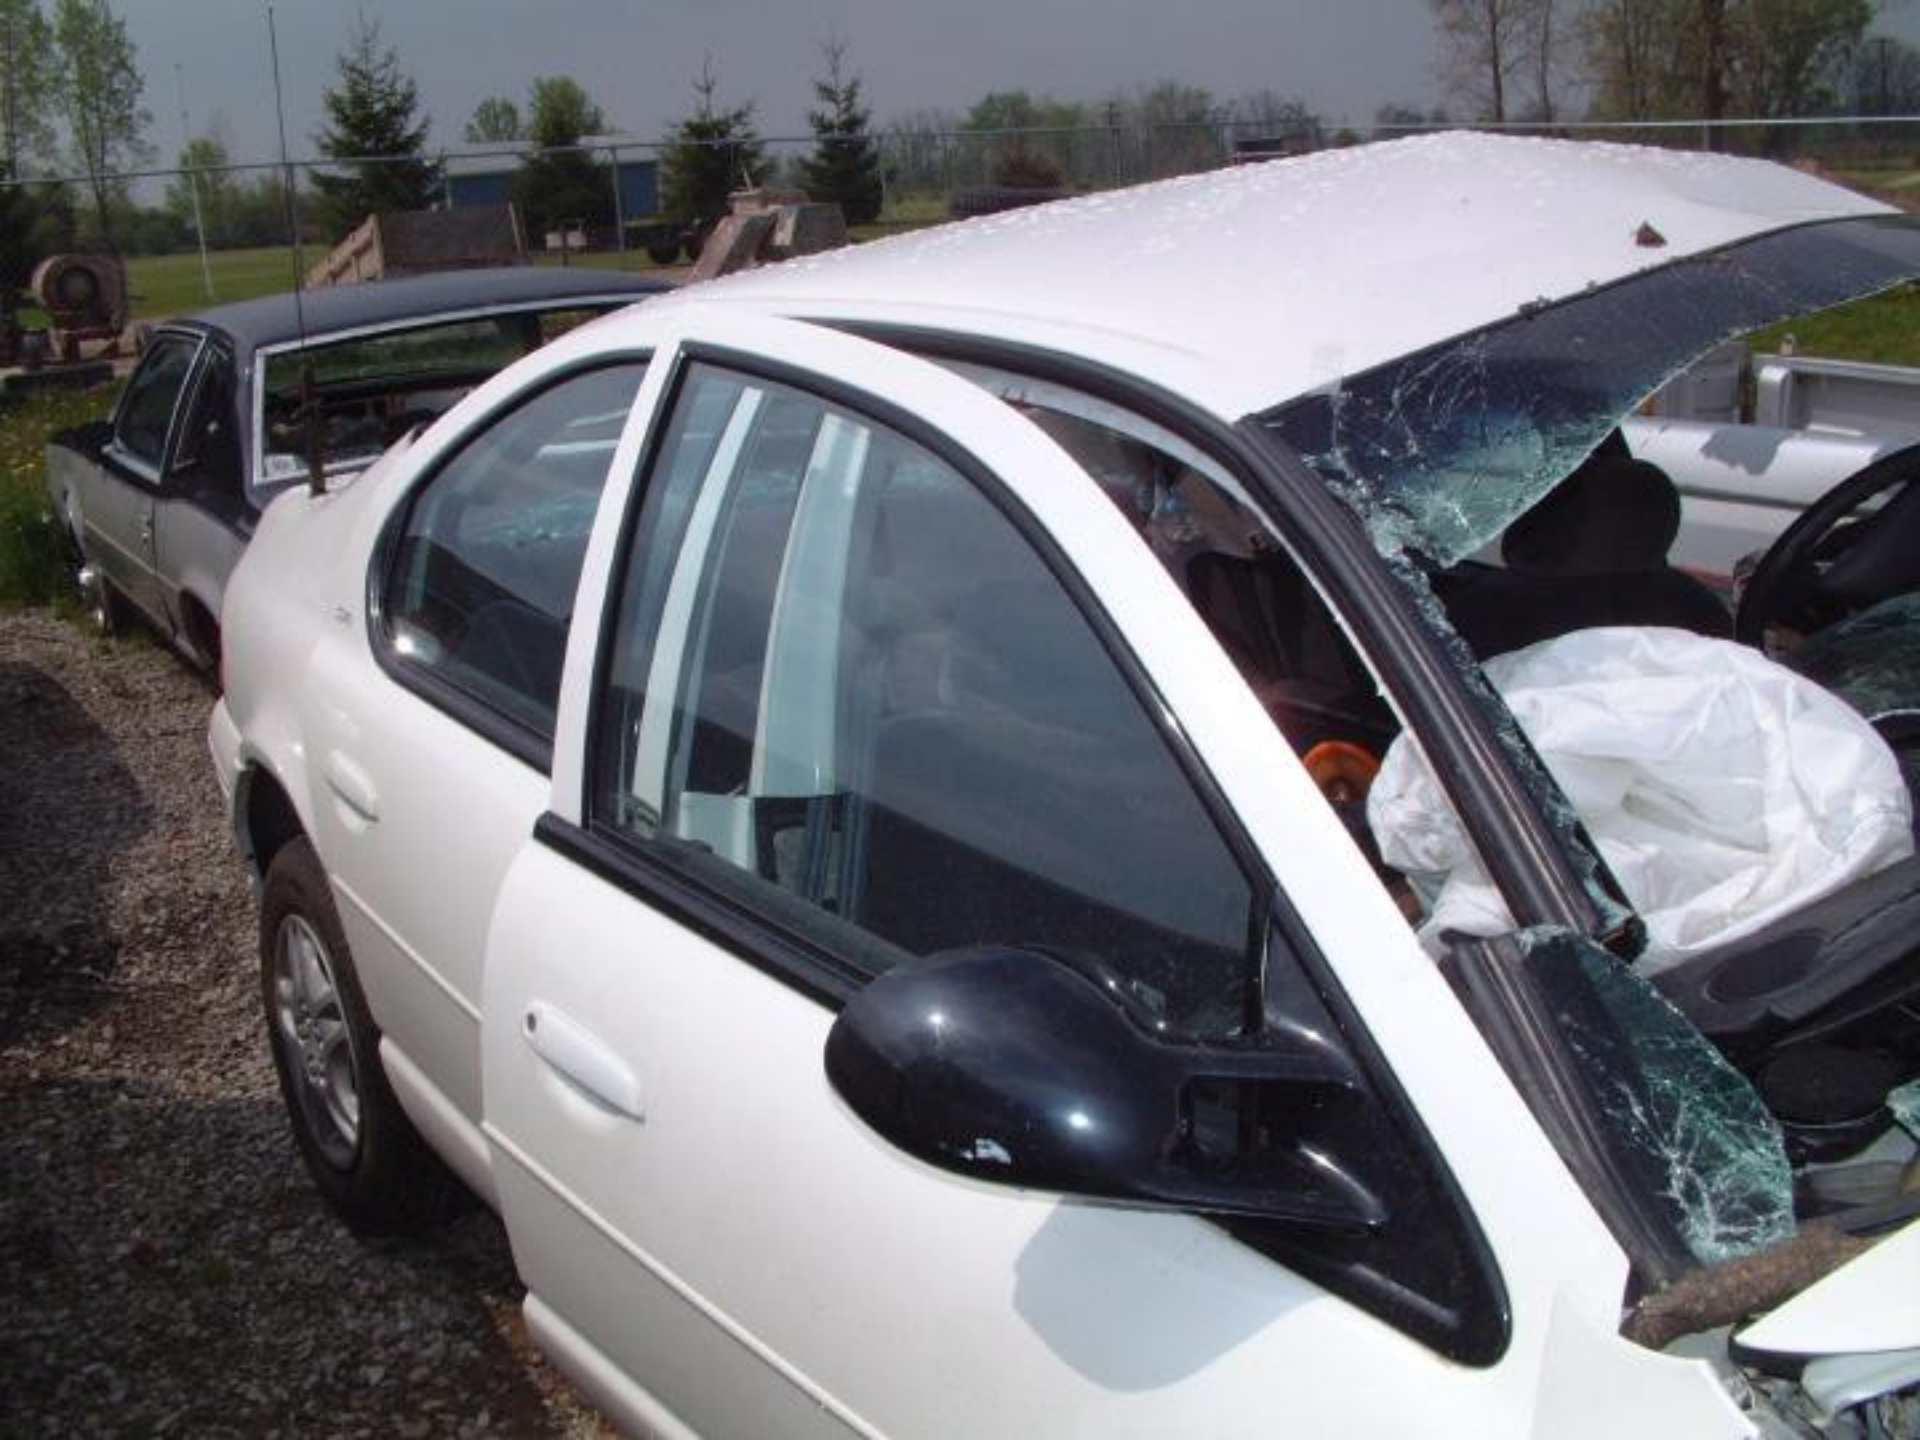
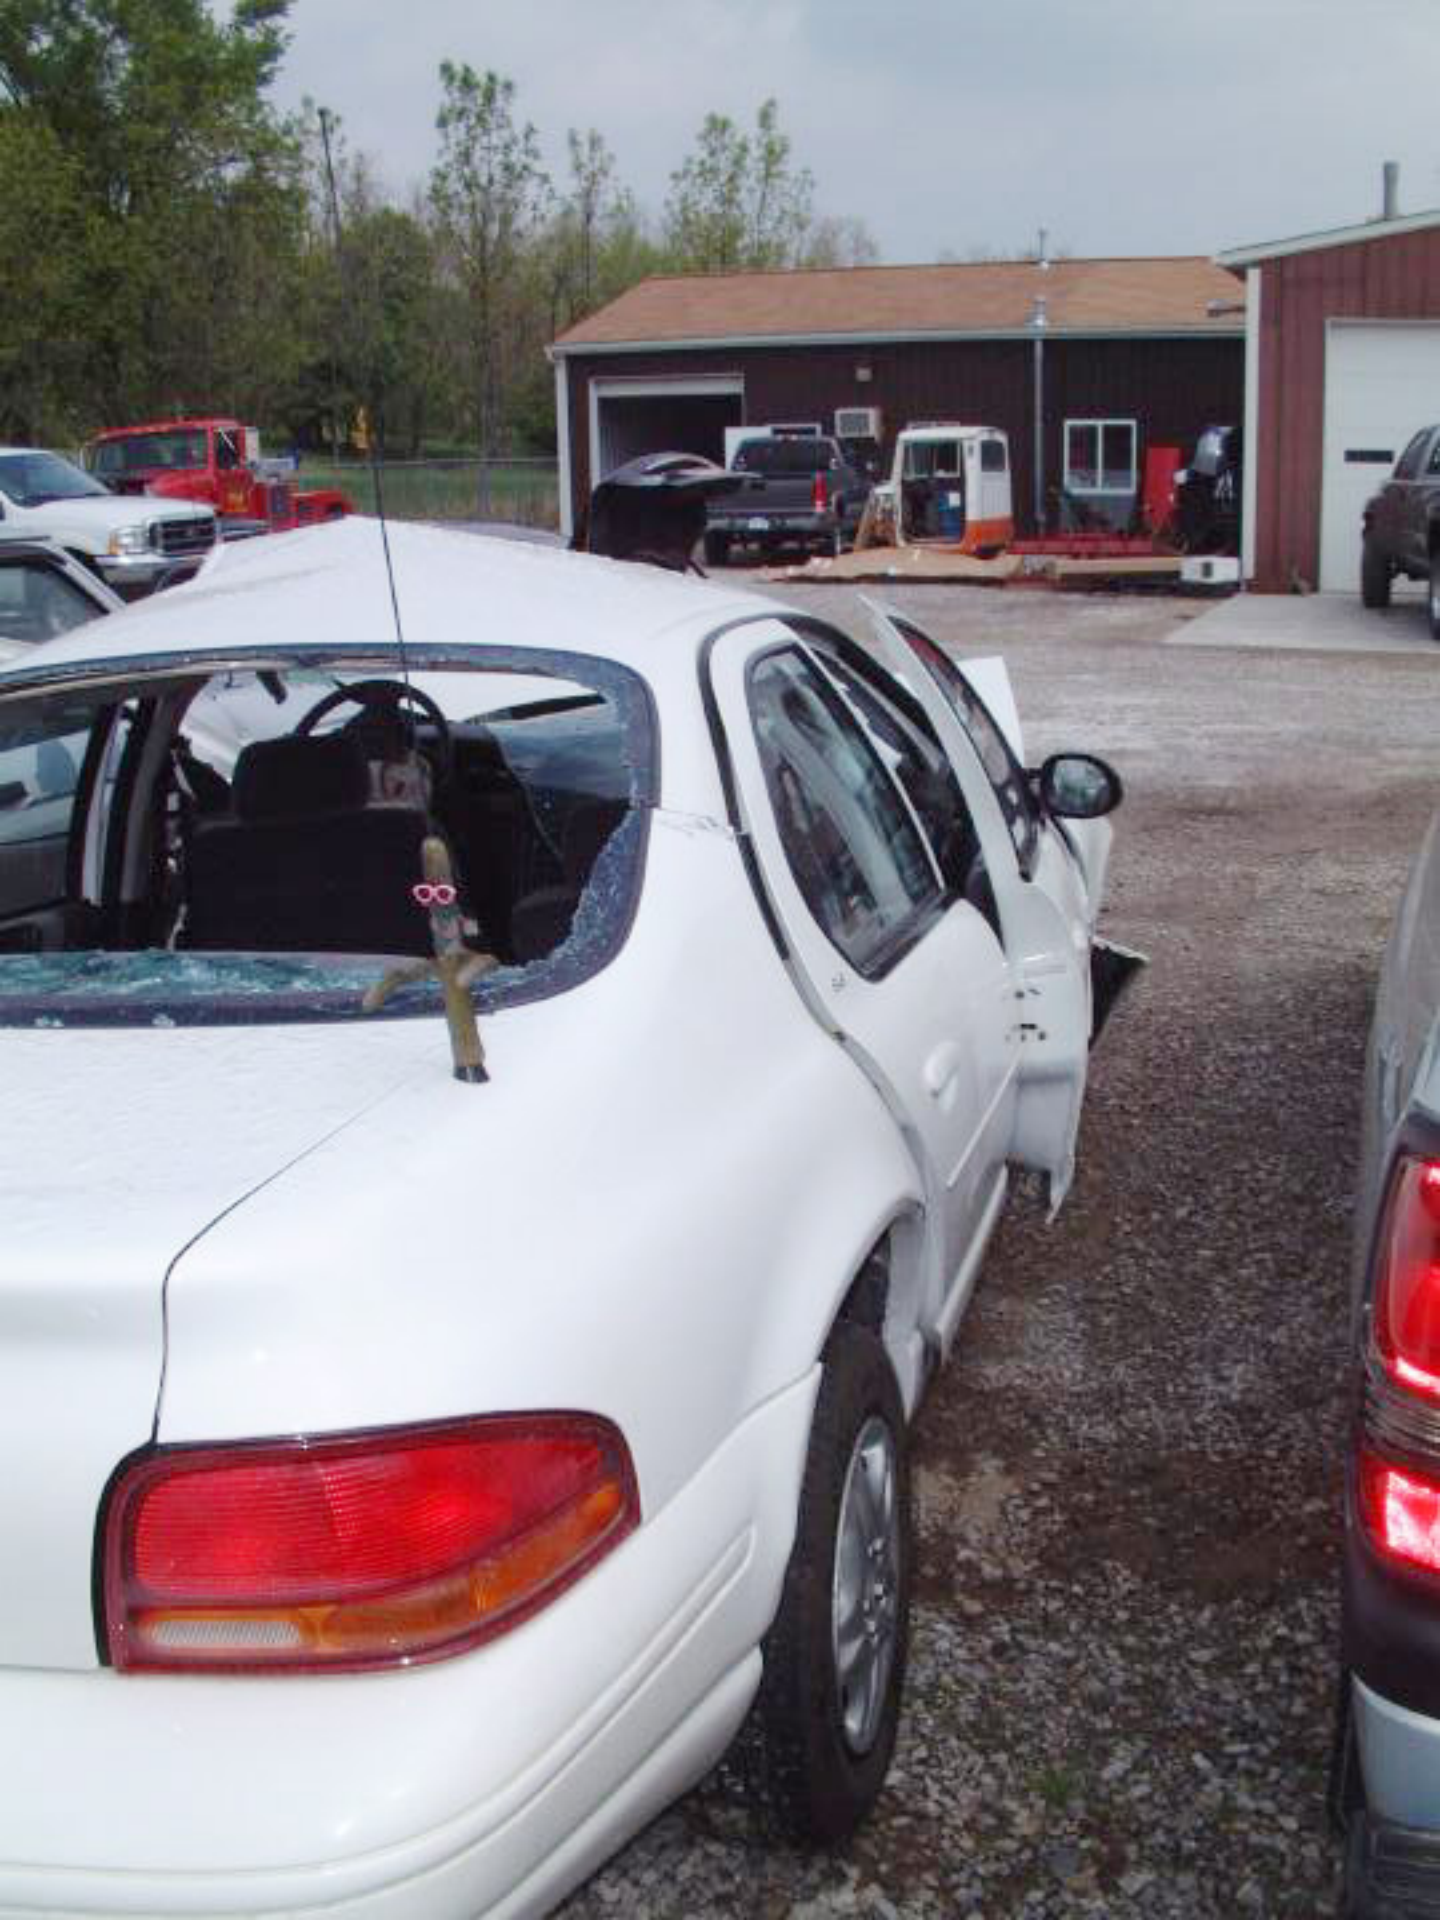
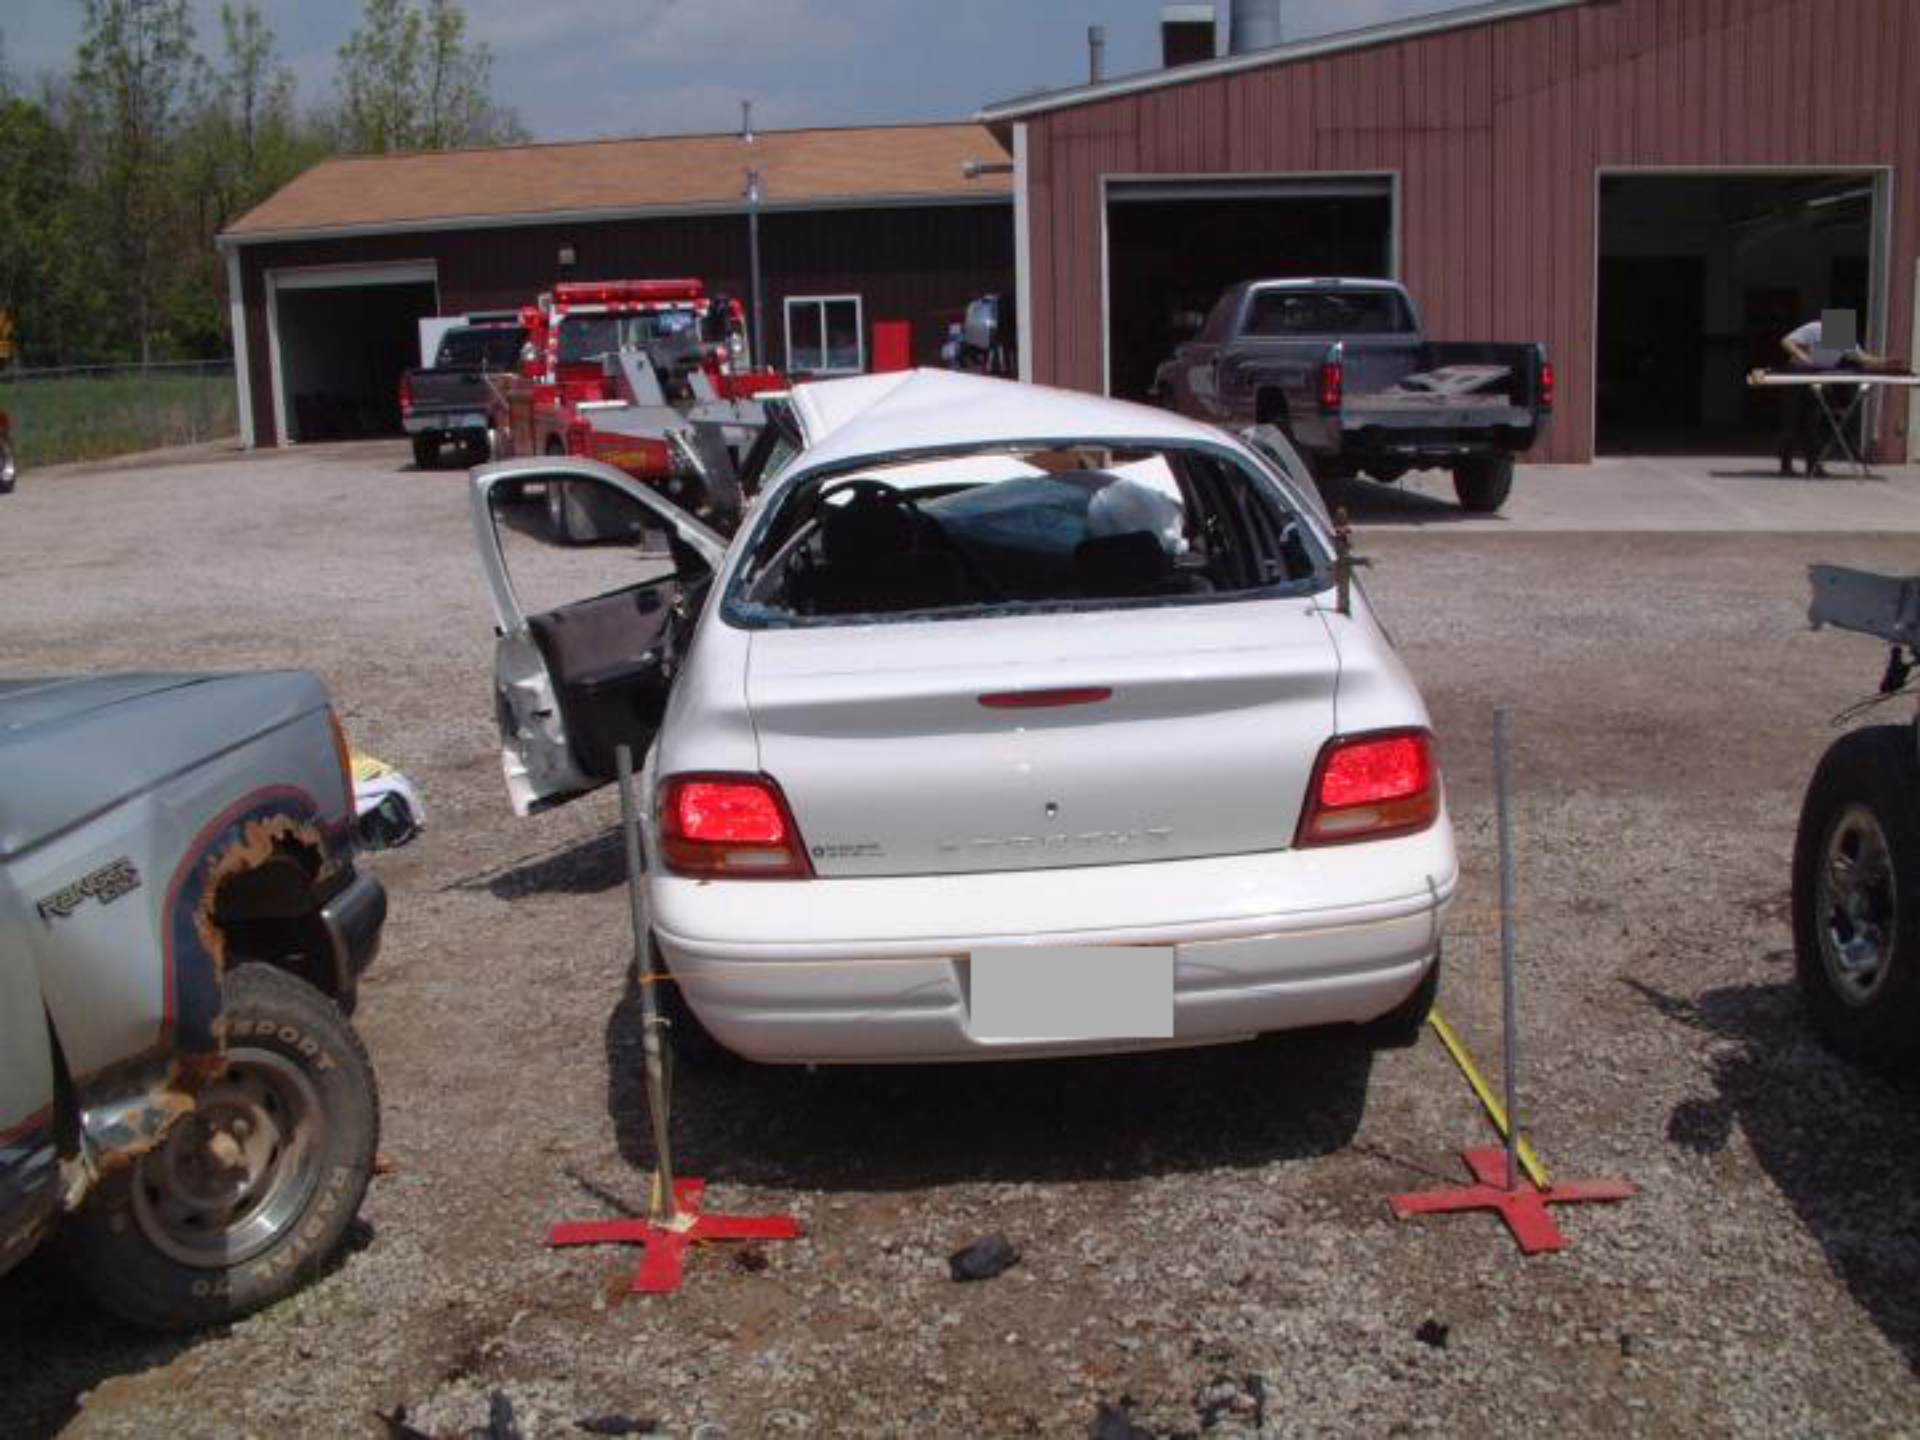
[51](#) [52](#) The left side of the roof and roof headliner, and the upper portion of the left A-pillar, were deformed and displaced up. [53](#) The upper and mid portions of the instrument panel and knee bolster were damaged and displaced rearward. [54](#) The ignition key and windshield wiper lever were pushed forward and the wiper control lever was broken. [55](#) The driver section of the toepan was displaced rearward and the brake pedal was bent. The driver's right shoe was wedged between the pedal and the displaced toepan, and [56](#) the driver's left shoe was wedged between the displaced toepan and the front of the seat. [57](#) [58](#) The plastic on driver-door armrest was cracked, and the door hardware and glass were broken. [59](#) The driver seat adjuster failed, allowing the seat to move and rotate forward during the crash.

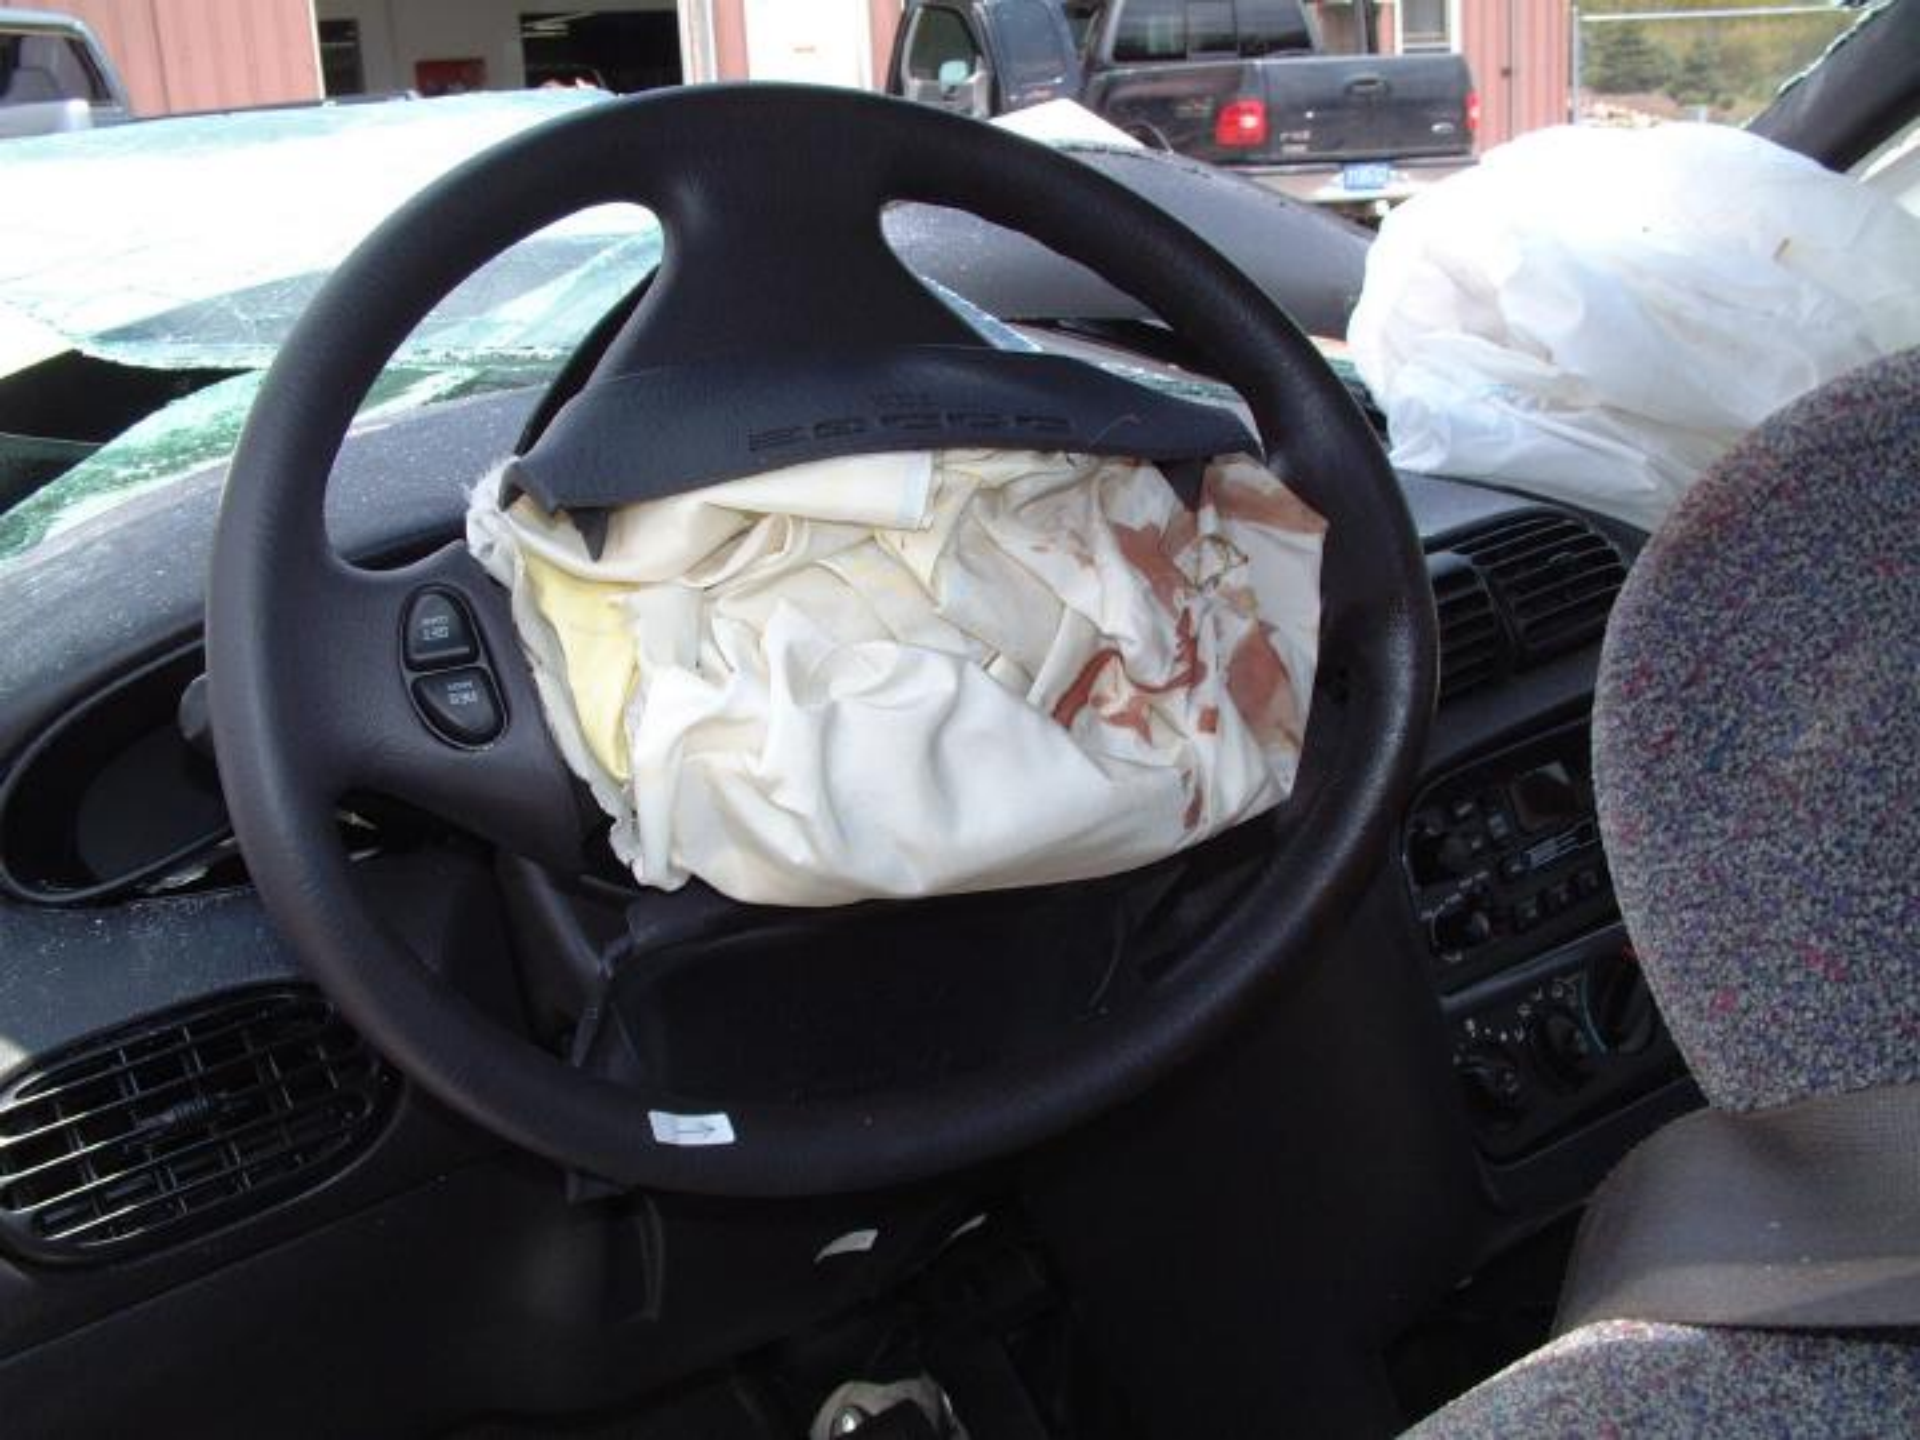
[60](#) There was no damage to the center section of the roof or the windshield header. [61](#) The vertical console was displaced rearward and the seat center console seats was crushed due to movement of the driver seat. The center rearview mirror was not available during the vehicle inspection.
